Manhole Inspection Summary

Manhole # S04II2008MH

Insp Date: **7/17/06 8:51 AM**

Location Address: **3311 SHELBURNE RD**

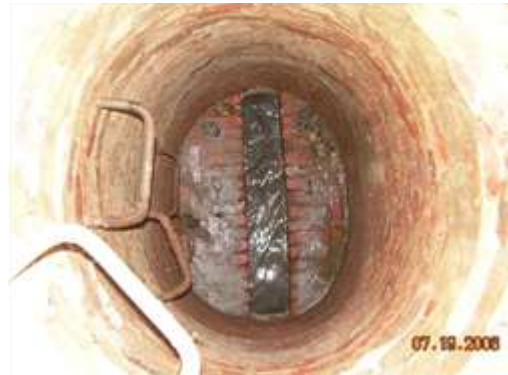
Top View

Adjustment, Corbel and Barrel infiltration.
Corroded steps. Evidence of surcharge -
Bench debris.

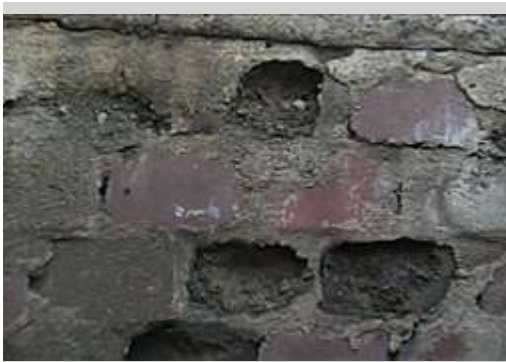
Defect

Adjustment and Corbel deterioration and
infiltration.

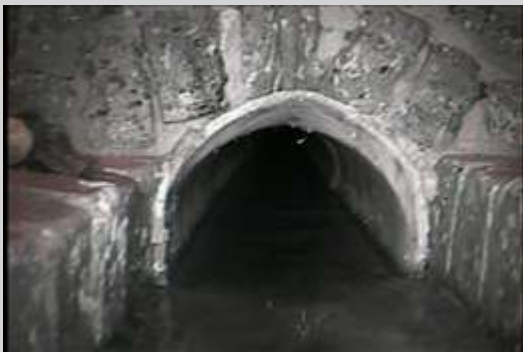
8 in. Circular Gravity Sewer Pipe Out @ 12 O'Clock

Deposits: ☐ None ☐ Mud ☐ Sludge ☒ **Debris** ☐ Grease

Silt Depth: **1** (in.) Deposits Extent: **Light**

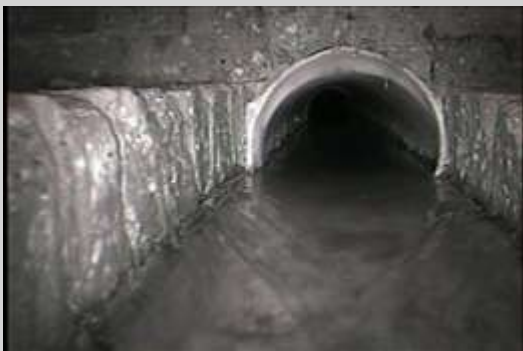
8 in. Circular Gravity Sewer Pipe In @ 6 O'Clock

Channel deterioration.

Deposits: ☐ None ☐ Mud ☐ Sludge ☒ **Debris** ☐ Grease

Silt Depth: **1** (in.) Deposits Extent: **Light**
